Conditions of Fukushima Dai-ichi Nuclear Power Station Unit 1 (As of 11:00 March 24th, 2011)

Conditions of Fukushima Dai-ichi Nuclear Power Station Unit 2

(As of 11:00 March 24th, 2011)

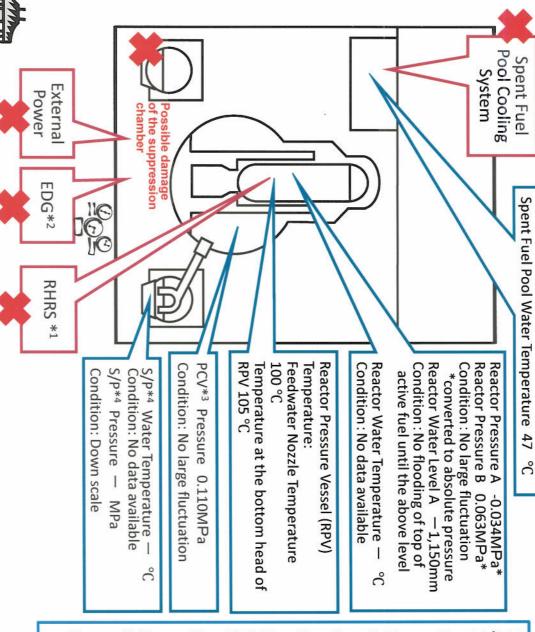
11th 15:42 Report based on the Article 10 (Total loss of A/C power)

11th 16:36 Occurrence of the Article 15 event (Inability of water injection of the Emergency Core Cooling System)

14th 13:25 Occurrence of the Article 15 event (Loss of reactor cooling functions)

14th 22:50 Occurrence of the Article 15 event (Unusual rise of the pressure in PCV)

15th 6:10 Sound of explosion

15th around 6:20 Possible damage of the suppression chamber

21st 18:22 White smoke generated. The smoke died down and almost invisible at 07:11 March 22nd.

Current Conditions: Water is being injected to Spent Fuel Pool and seawater is being injected to the core

20th 15:05~17:20 Approximately 40 ton seawater injection to the Spent Fuel Pool (SFP) via Fuel Pool Cooling System (FPC) 20th 15:46 Power Center received electricity.

22nd 16:07 Injection of around 18 tons of seawater to the Spent Fuel Pool

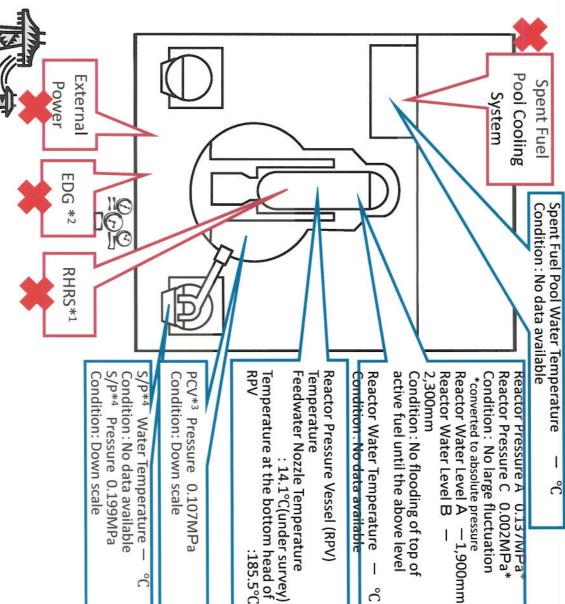
Conditions of Fukushima Dai-ichi Nuclear Power Station Unit 3

11th 5:42 Report based on the Article 10 (Total loss of A/C power)

13th 5:10 Occurrence of the Article 15 event (Inability of water injection of the Emergency Core Cooling System)

14th 7:44 Occurrence of the Article 15 event (Unusual rise of the pressure in PCV

14th 11:01 Sound of explosion

17th 9:48 ~ 10:01 Water discharge by the helicopters of 16th around 8:30 White smoke generated

20th 11:00 Pressure of PCV rose(320kPa). Afterward fell $20^{\text{th}} 20:39 \sim 21^{\text{st}} 3:58 \text{ Water spray by Tokyo Fire}$

21st about 15:55 Grayish smoke generated and was confirmed to be died down at 17:55.

24th 5:35 Injection of sea water to SFP via FPC 23rd around 16:20 Black smoke generated and was confirmed to died down at around 23:30 and 24th 4:50

Current Conditions: Water spray to Spent Fuel Pool and sea water injection to

13th 13:12 Started to inject seawater and borated water to

23^{rd} 11:03 \sim 13:20 Injection of about 35ton of sea water to the Spent Fuel Pool (SFP) via the Cooling and

(12:08 Confirmed the injection of $4^{\sim}5t/h$)

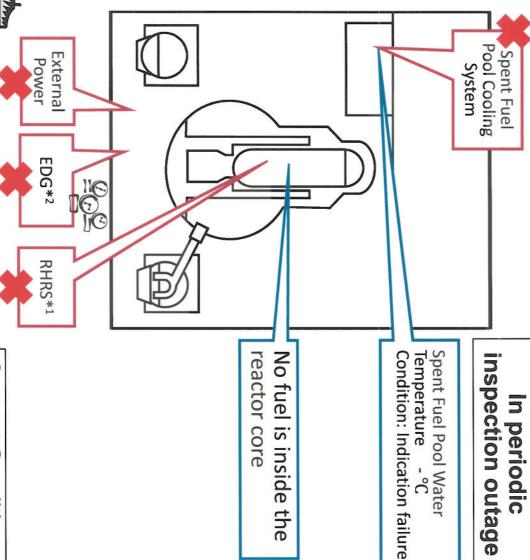
Conditions of Fukushima Dai-ichi Nuclear Power Station Unit 4

In periodic inspection outage when the earthquake occurred.

11th 15:42 Report based on the Article 10 (Total loss of A/C power)

14th 4:08 Water temperature in the Spent Fuel Pool, 84°C

15th 6:14 Partial damage of wall in the 4th floor confirmed

15th 9:38 Fire occurred in the 3rd floor.

16th 5:45 Fire occurred. TEPCO couldn't confirm any fire on the ground. (6:15) 20th 8:21~9:40 Water spray over the Spent Fuel Pool by Self-Defense Force

Current Conditions: No fuel is in RPV*3. Water spray to Spent Fuel Pool

21st about 15:00 Work for laying cable to Power Center was completed.

22nd 10:35 Power Center received electricity 22nd 17:17 ~ 20:32 Water spray by Concrete Pump Track

23rd 10:00∼13:02 Water spray by Concrete Pump Track
