# Information on Status of Nuclear Power Plants in Fukushima

Japan Atomic Industrial Forum, Inc.

**Status of nuclear power plants in Fukushima as of 12:00, April 28th (Estimated by JAIF)**

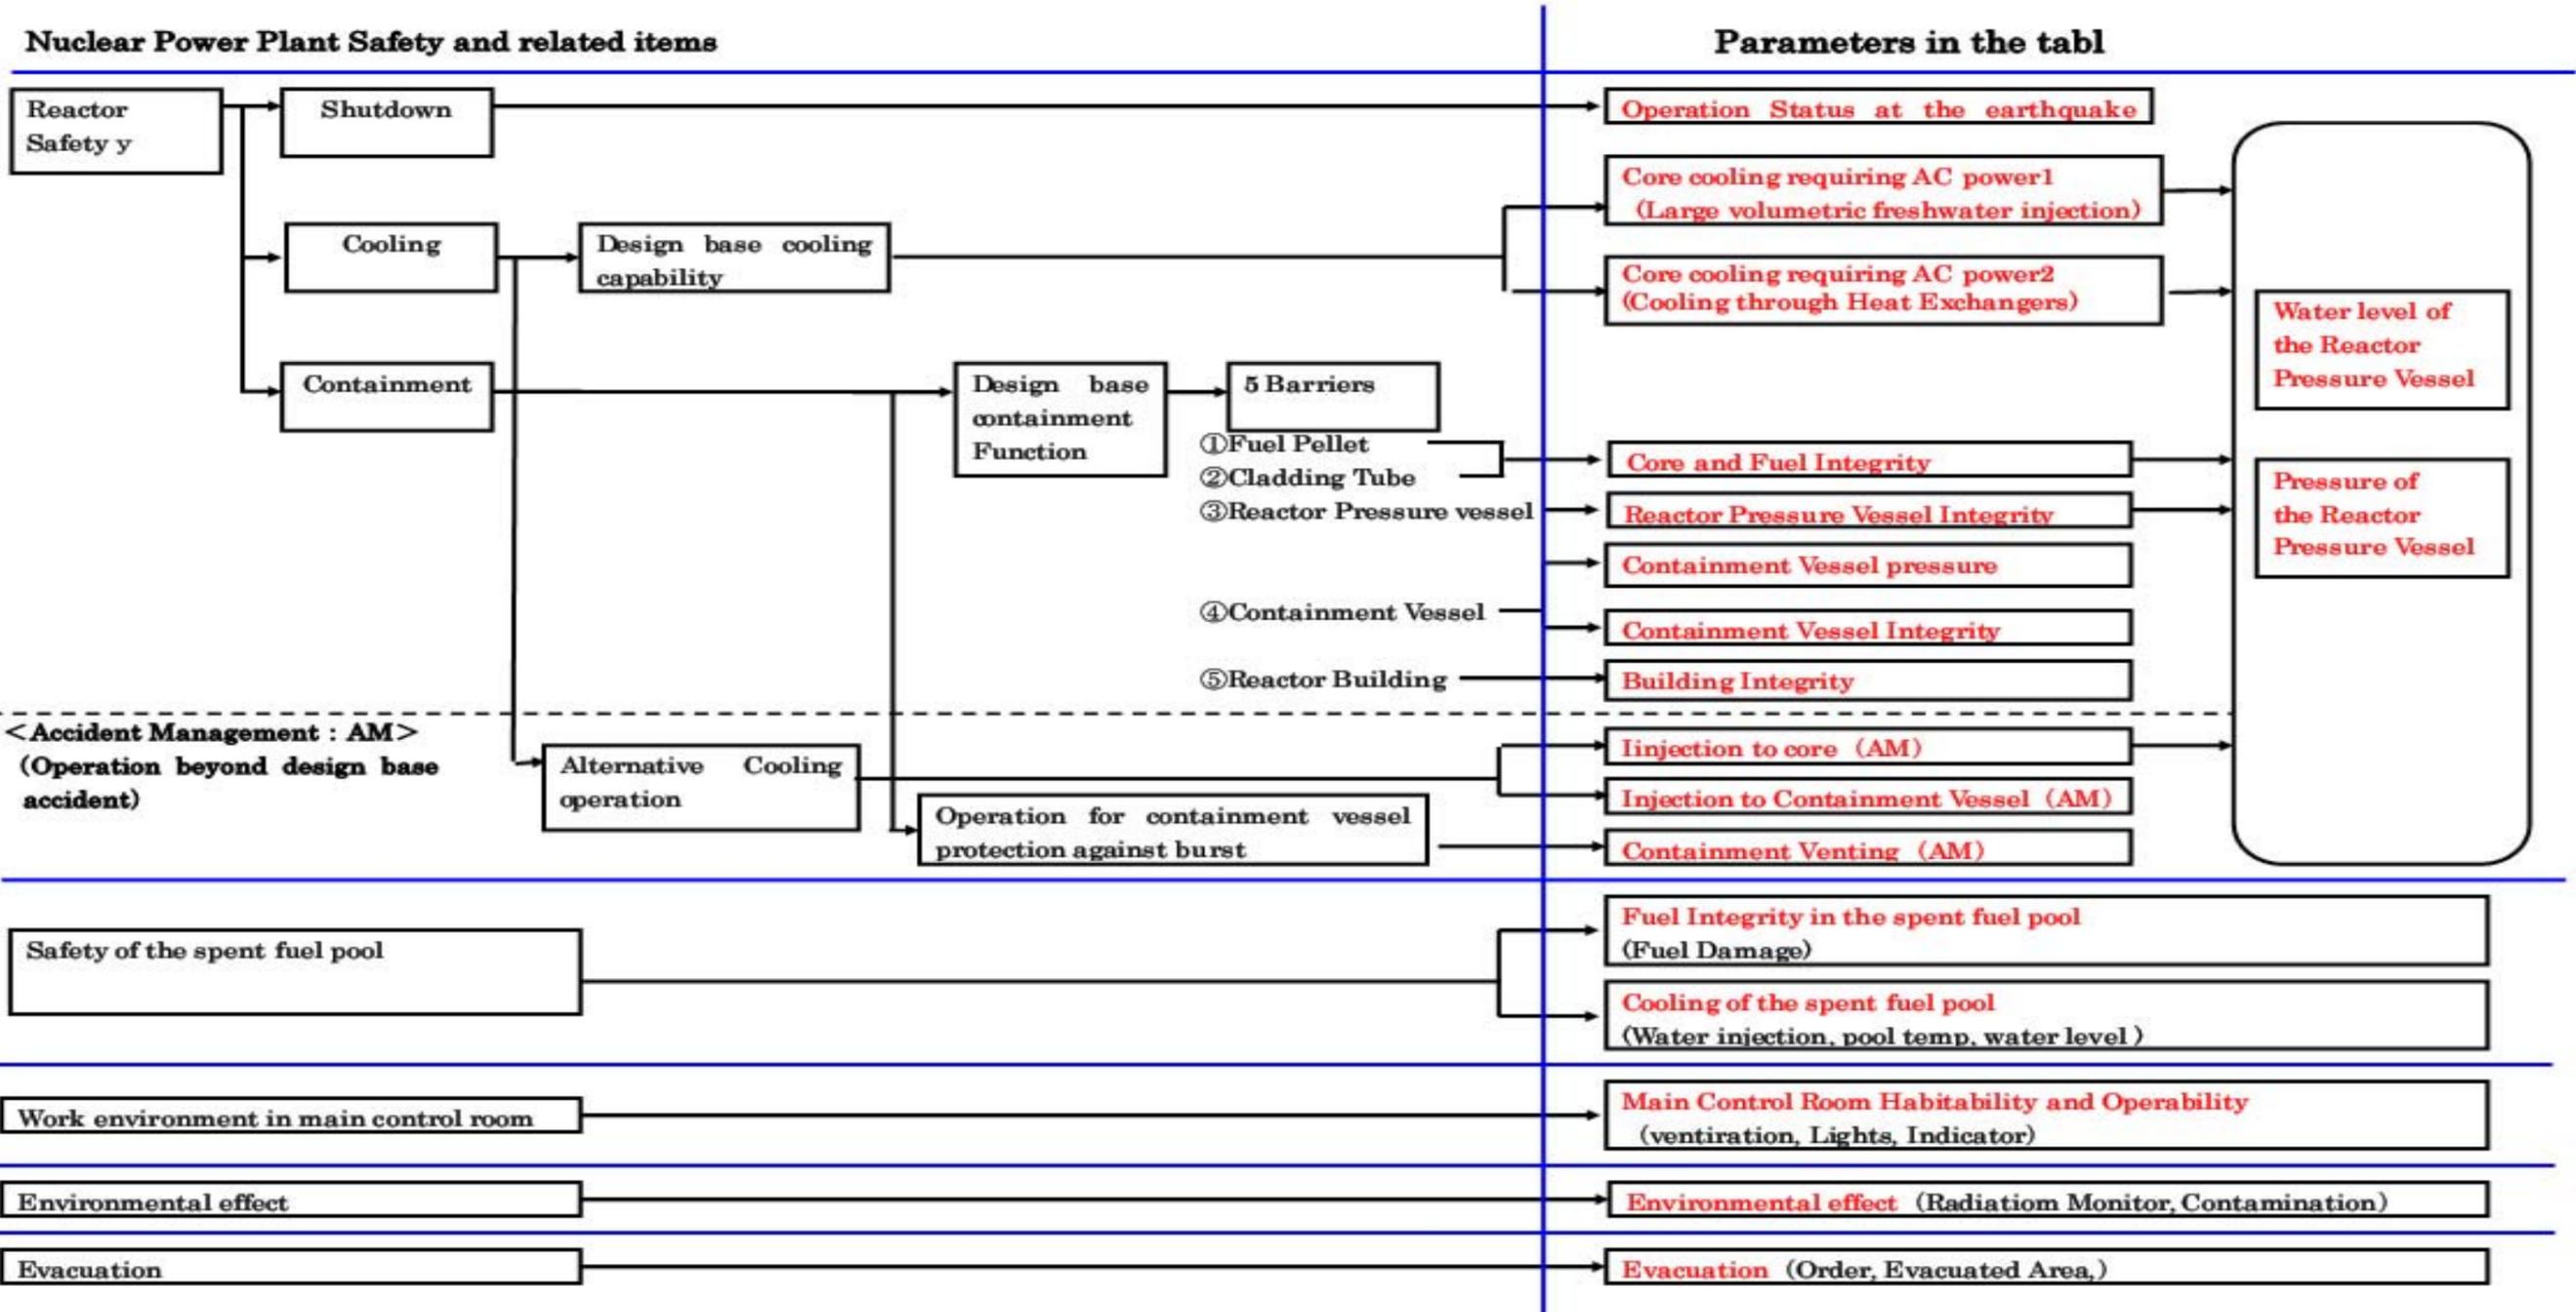
**Parameters in the Table**

JALIF picks up these parameters to evaluate safety condition of the nuclear plants during this accident from the view point of the principles of nuclear power plant safety, which are "Shutdown", "Cooling" and "Containment". Then we create the chart. The following diagram is to show the correspondence relation of these parameters in the table to nuclear power plant safety.

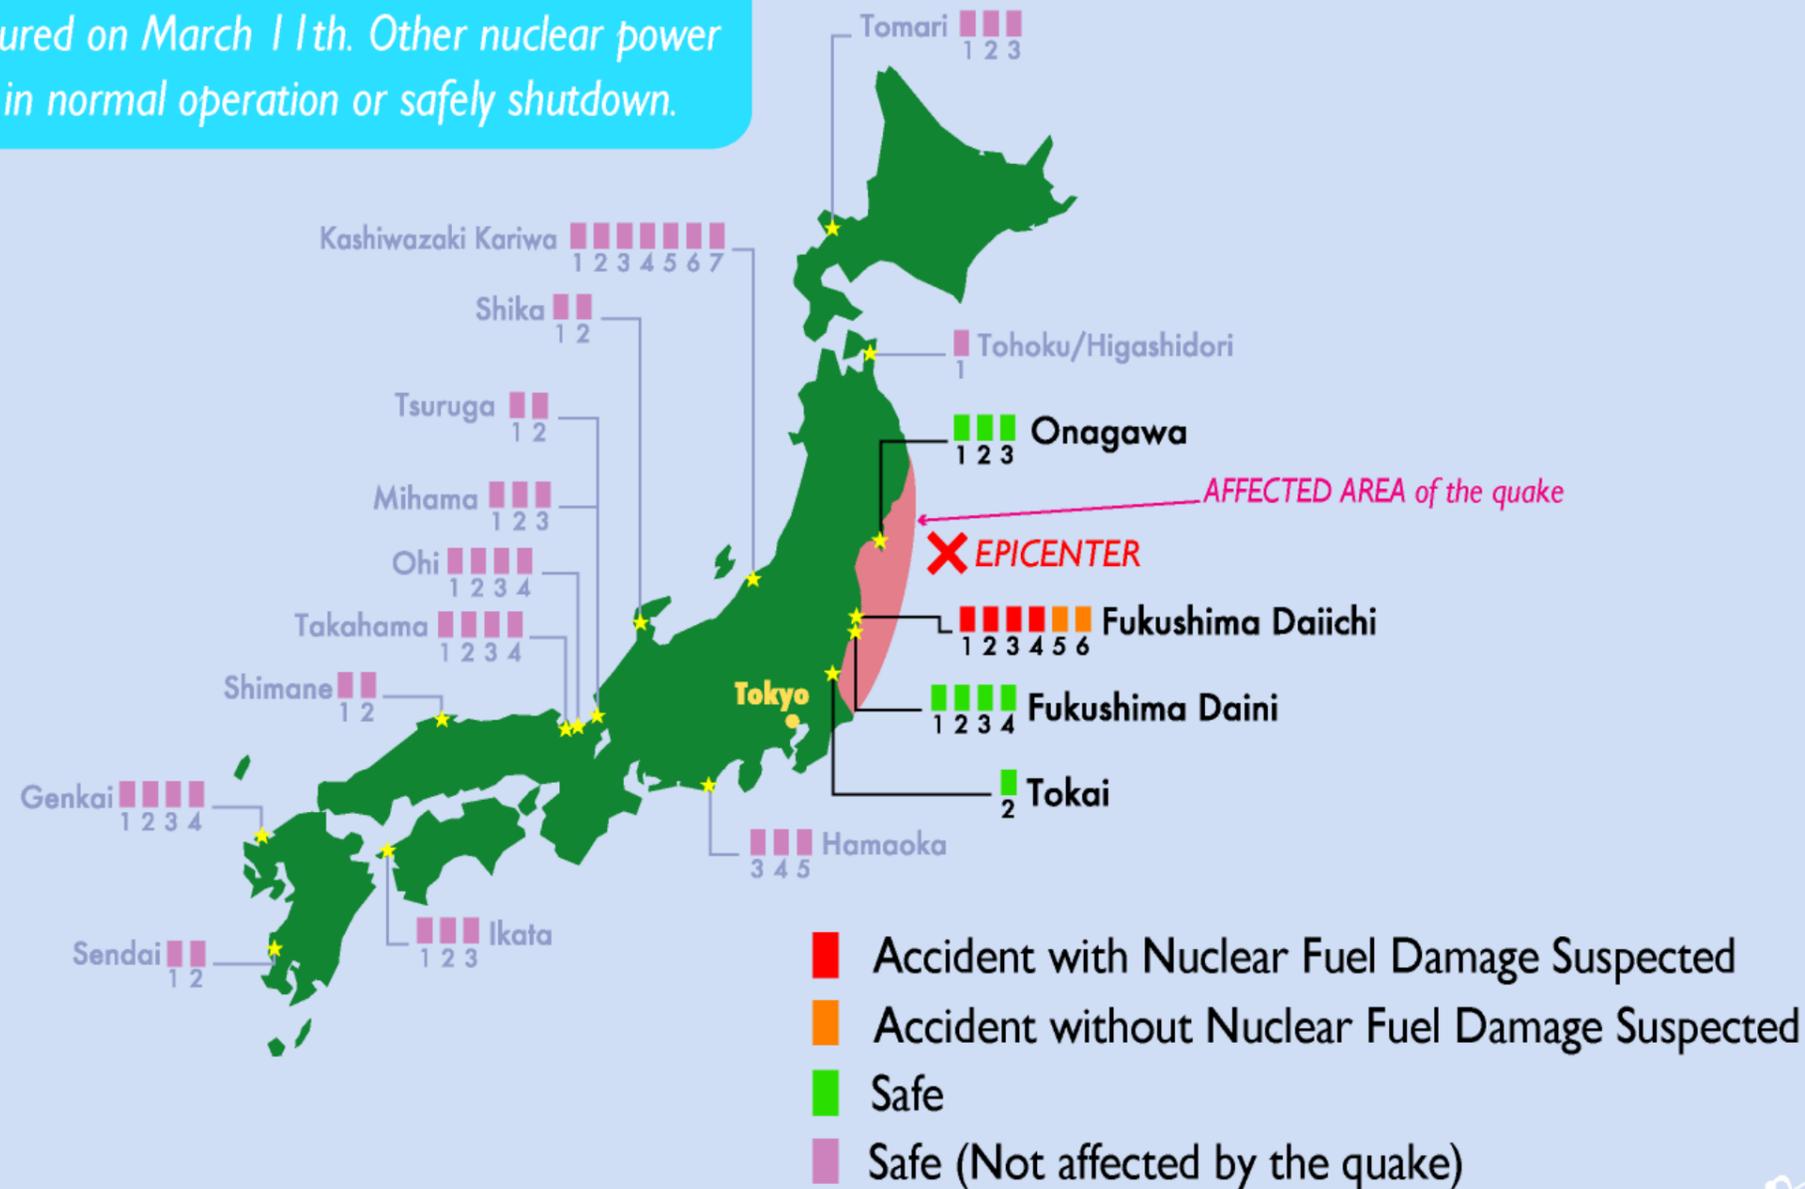
# Status of the Nuclear Power Plants after the Earthquake

The accident that brings environmental impact is going on at several units in Fukushima Daiichi nuclear power Station after the earthquake occurred on March 11th. Other nuclear power plants in Japan are in normal operation or safely shutdown.
