Information on Status of Nuclear Power Plants in Fukushima

Japan Atomic Industrial Forum, Inc.

Status of nuclear power plants in Fukushima as of 12:00, May 3rd (Estimated by JAIF)

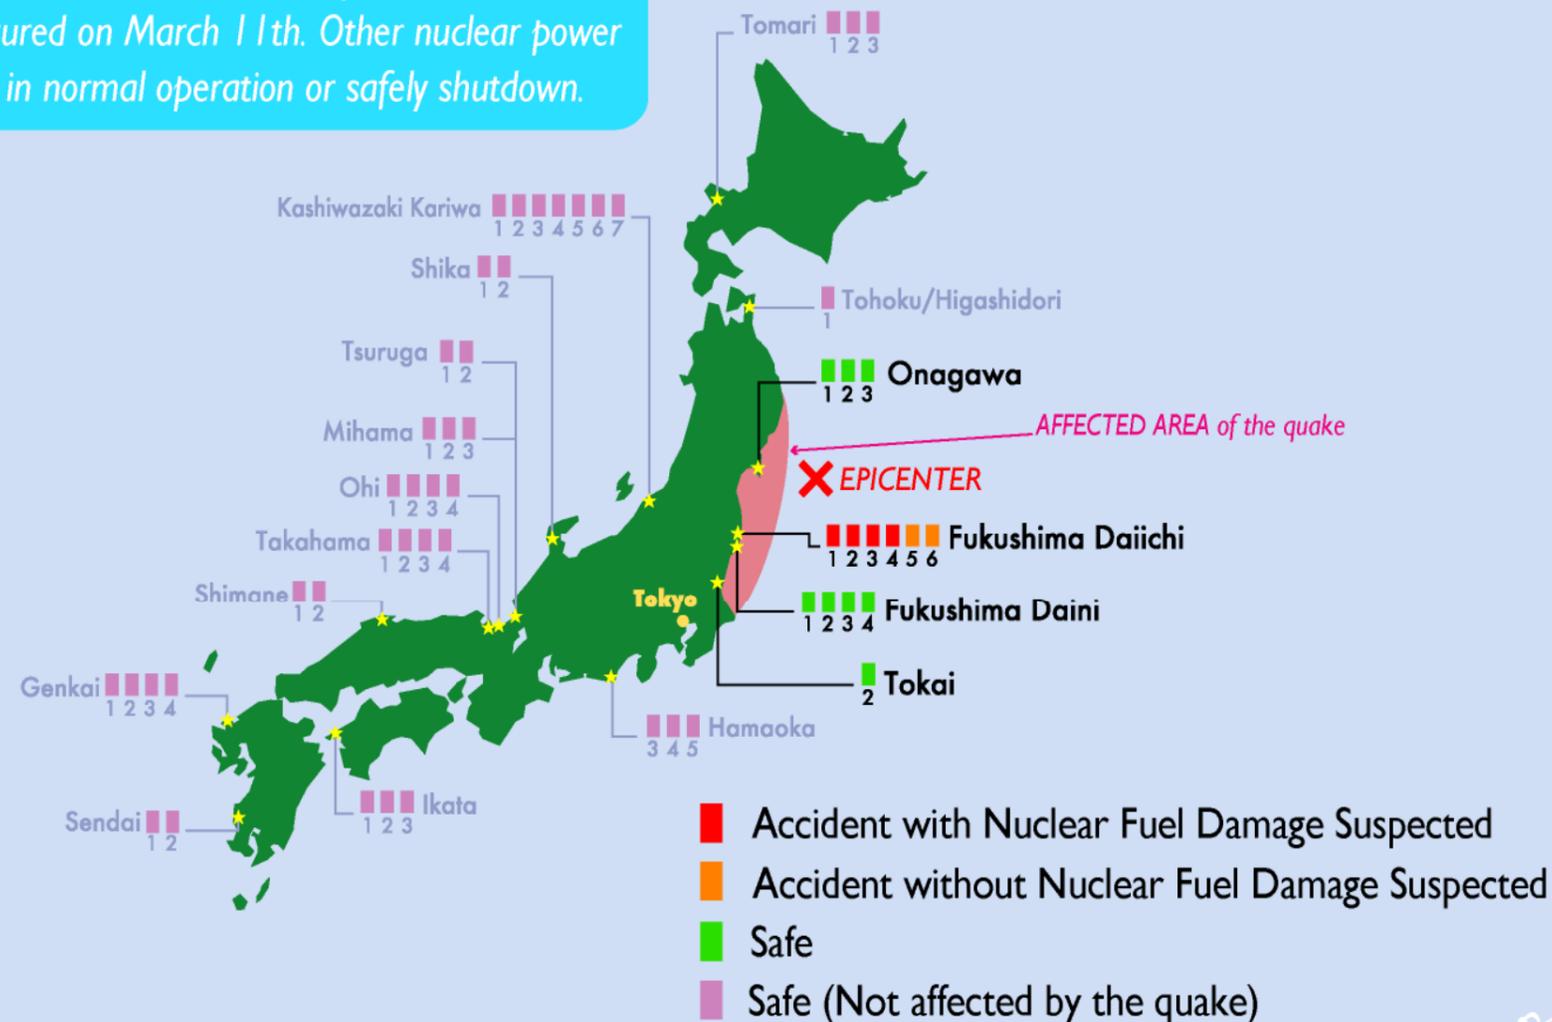
Status of the Nuclear Power Plants after the Earthquake

The accident that brings environmental impact is going on at several units in Fukushima Daiichi nuclear power Station after the earthquake occurred on March 11th. Other nuclear power plants in Japan are in normal operation or safely shutdown.
