Information on Status of Nuclear Power Plants in Fukushima

Japan Atomic Industrial Forum, Inc.

Status of nuclear power plants in Fukushima as of 12:00, May 10th (Estimated by JAIF)

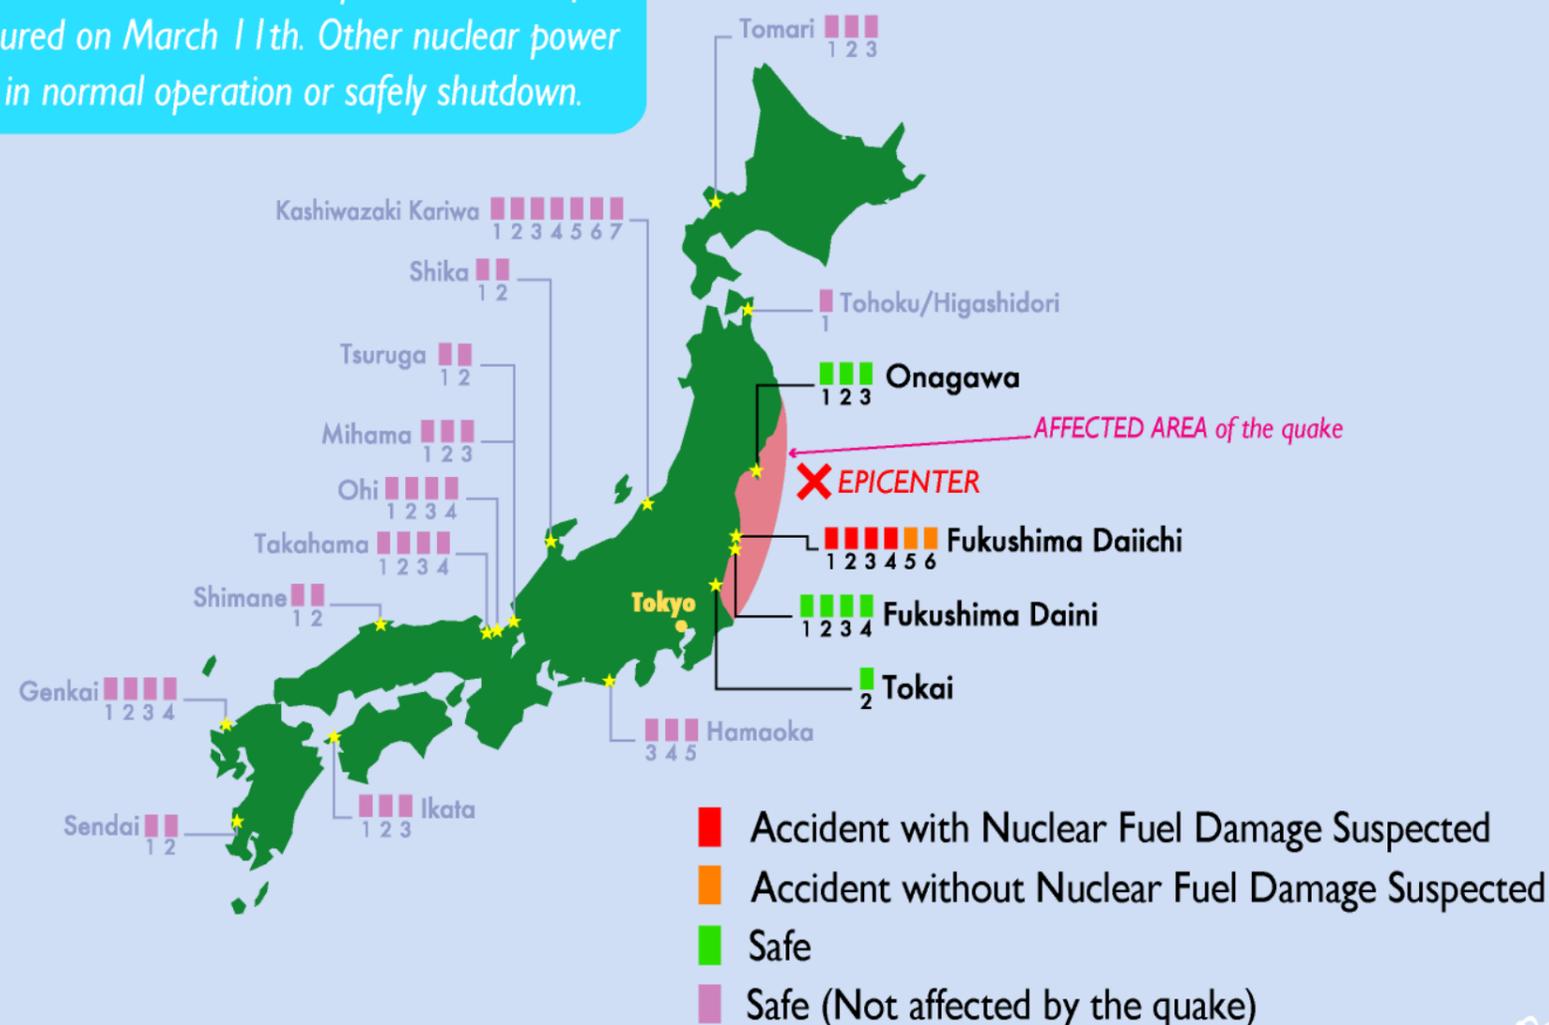
Status of the Nuclear Power Plants after the Earthquake

The accident that brings environmental impact is going on at several units in Fukushima Daiichi nuclear power Station after the earthquake occurred on March 11th. Other nuclear power plants in Japan are in normal operation or safely shutdown.
